# **O-HEAT**

To: The Green Family  
Re: Home energy efficiency survey

## **INTRODUCTION**

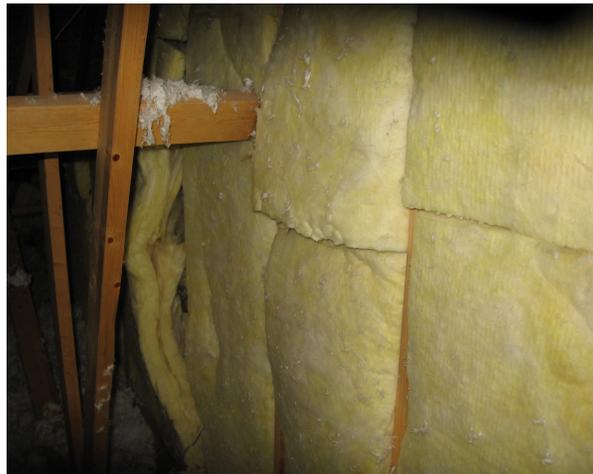
The attic walls (knee walls) are insulated with fiberglass batts, some of which are sagging. Gravity tends to make batts slump over time. Batt must be neat and in full contact with the wall to be effective. Convection currents can wash heat out of vertically-oriented fiberglass that is not covered with an air-barrier. A solution is to cover the batts with a vapor-permeable air barrier, such as house-wrap or foam board, and seal the edges so that the fiberglass is completely enclosed.

*Illustration 1: Kneewall insulation, Green Residence*
